Subject: Interim Measures Action Summary Letter for The Dow Chemical Company, Hanging Rock Plant, Ironton, OH EPA ID# OHR 000 157 727 and OHD 039 128 913

Hanging Rock Facility - Building 505  
Photolog Interim Mitigation Actions

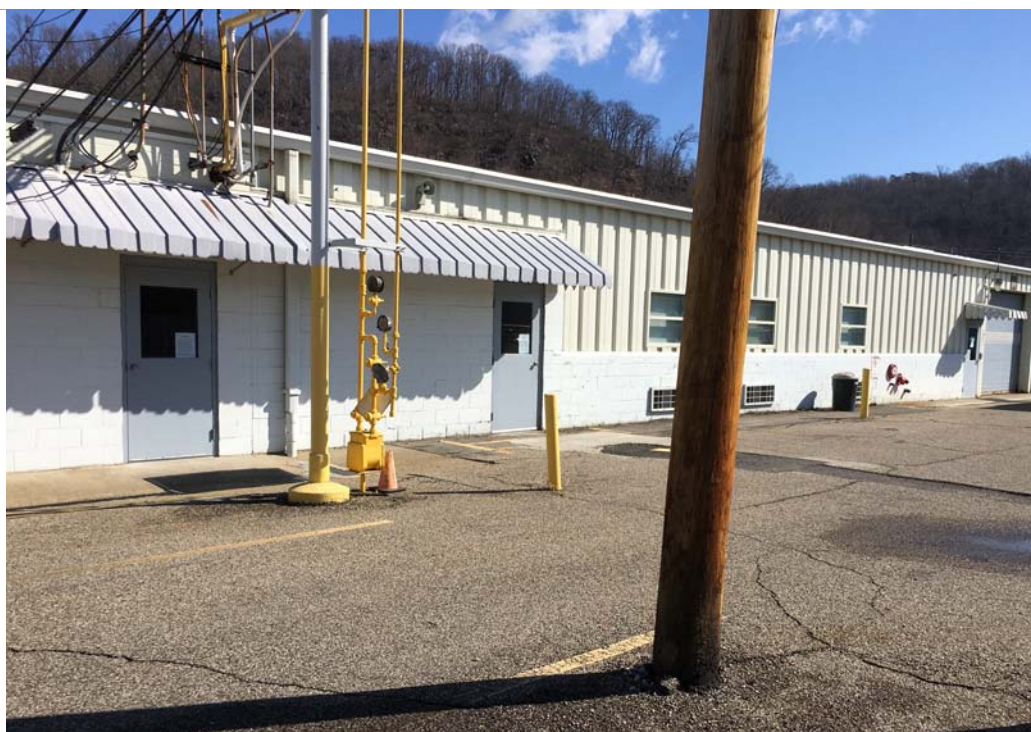
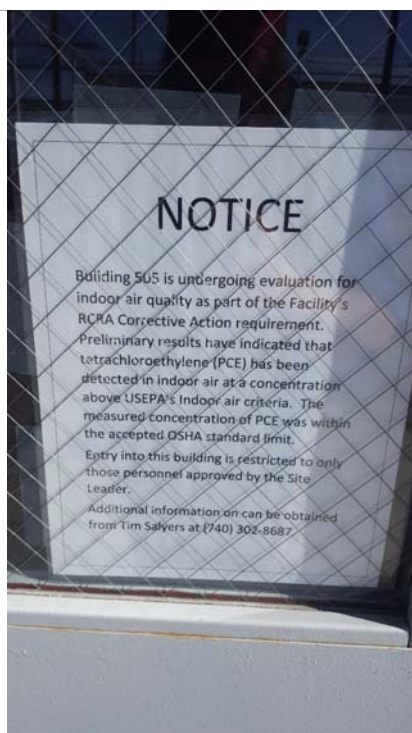
| <b>Description:</b> | Door notices | | | | |

| <b>Description:</b> | Door notice closeup | | | | |

- Relocated the Building 505 office worker to a temporary work space trailer placed in the Building 505 parking lot.
- Placed a notice on the building outside doors that include the following statements:  
“...tetrachloroethylene (PCE) has been detected in indoor air at a concentration above USEPA's indoor air criteria. Entry into this building is restricted to only those personnel approved by the Site Leader.” Photographs of the notice are included in Attachment 1.

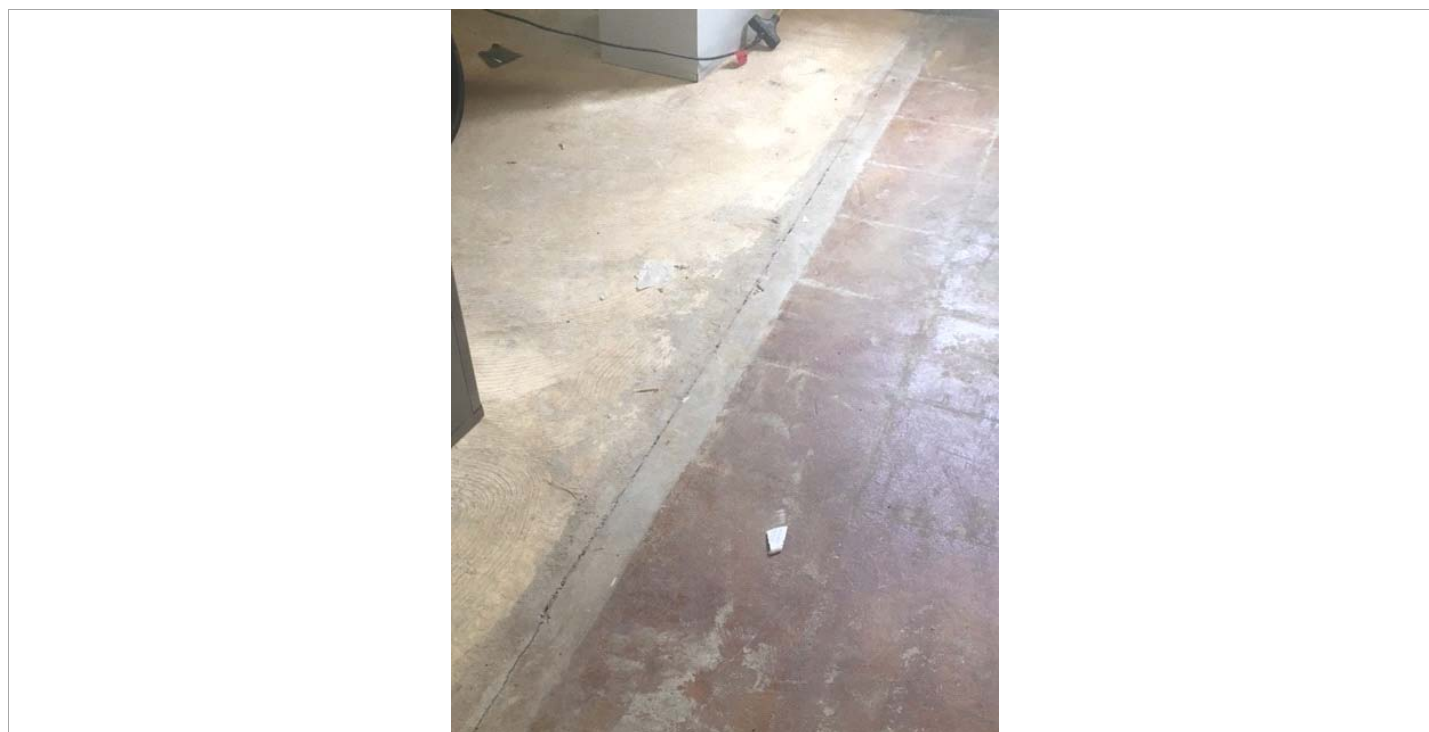
- Performed a visual building survey that identified three potential vapor entry pathways: A crack in the slab in the southwest corner storage room and in an interior electronic parts storage room, and a gap around the fire water riser pipe, a 6-inch-diameter pipe that comes through the floor.

The two floor cracks were also sampled with the HAPSITE. Samples collected from both cracks (PP-1 and PP-2) showed elevated concentrations of PCE (1,800 and 770  $\mu\text{g}/\text{m}^3$ , respectively) and TCE (140 and 5.6  $\mu\text{g}/\text{m}^3$ , respectively), which suggests that these serve as potential vapor entry points. The air in the enclosed space between the slab and the elevated floor in interior electronic parts storage room (i.e., approximately a foot above the cracks) was also sampled (PP-2). PCE and TCE concentrations (130 and 5.6  $\mu\text{g}/\text{m}^3$ , respectively) in this space were detected.

| <b>Description:</b> | Crack where wall was removed to open up southwest corner room-Before | | | | |

These were sealed on April 4, 2018, using the high-performance polyurethane sealant Sikaflex®-1C SL. Plumbers putty and a plastic o-ring were used to fill the gap around the fire water pipe before the sealant was applied. Photographs of the cracks/gaps before and after sealing are included in Attachment 1.

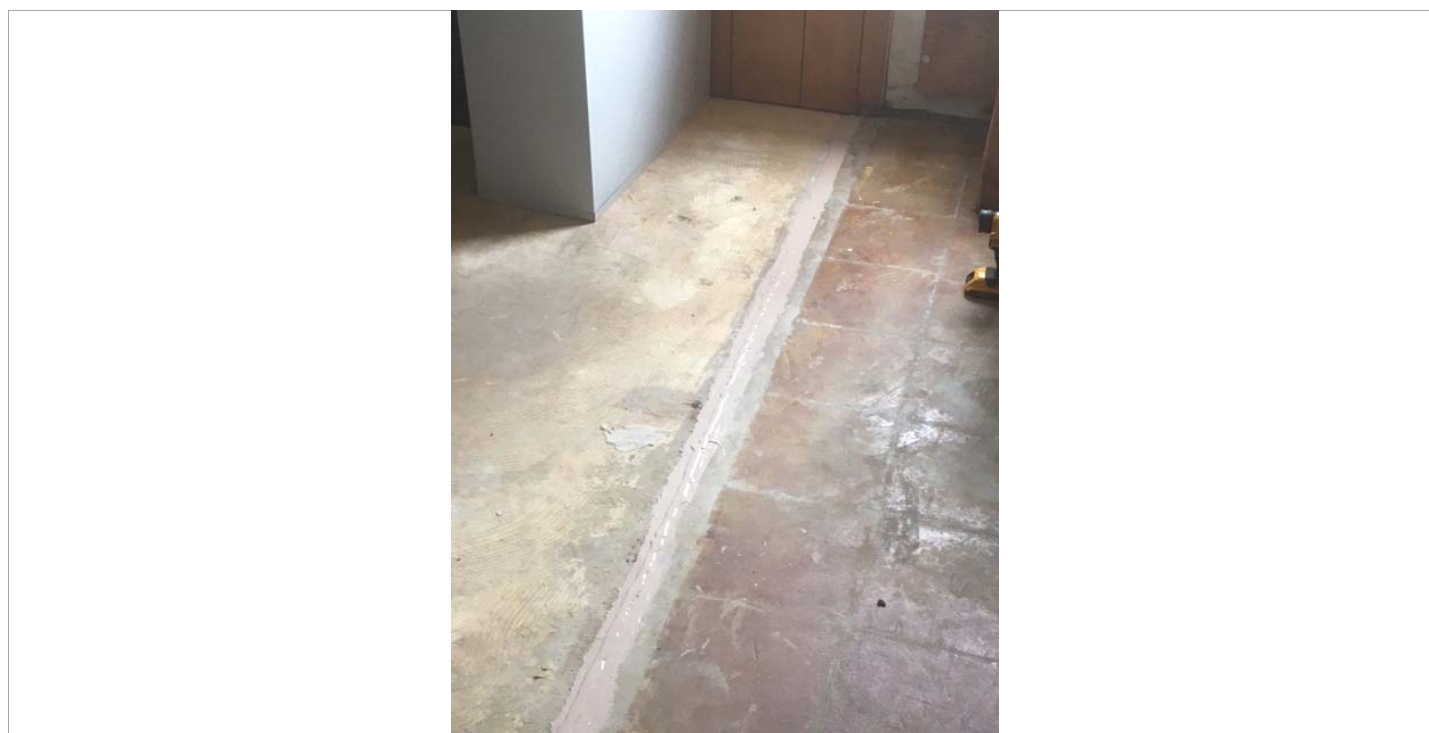
| <b>Description:</b> | Crack where wall was removed to open up southwest corner room-After | | | | |

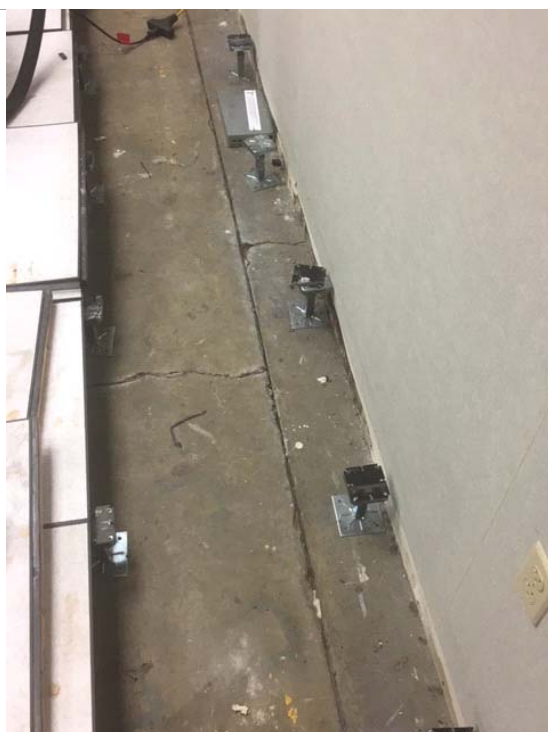
| <b>Description:</b> | Crack below raised floor in interior computer parts room-Before | | | | |

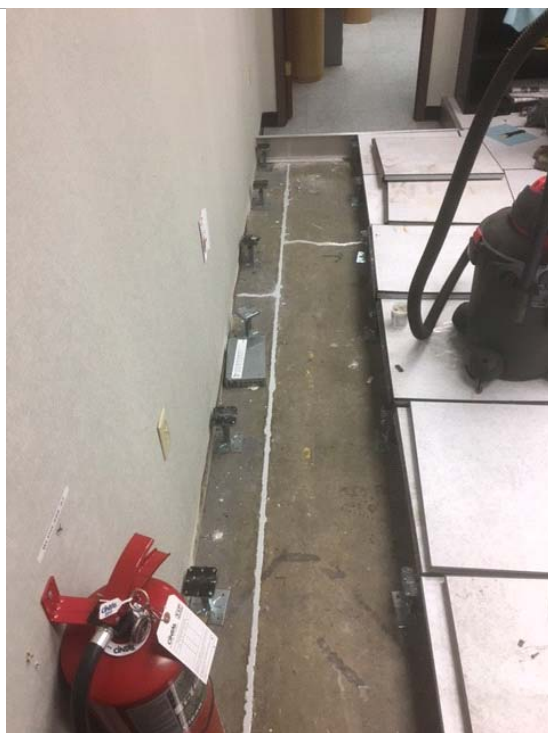
| <b>Description:</b> | Crack below raised floor in interior computer parts room-After | | | | |

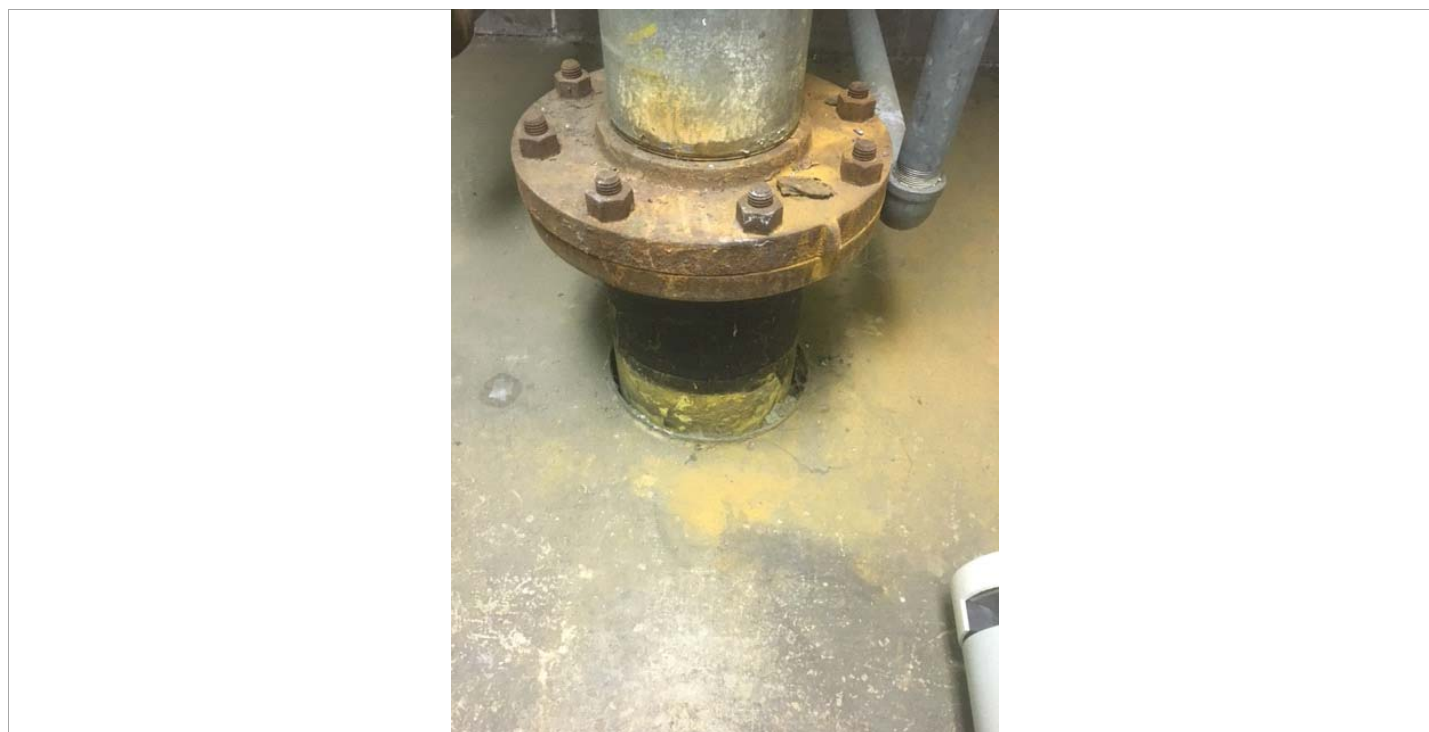
| <b>Description:</b> | Fire water riser pipe - before | | | | |

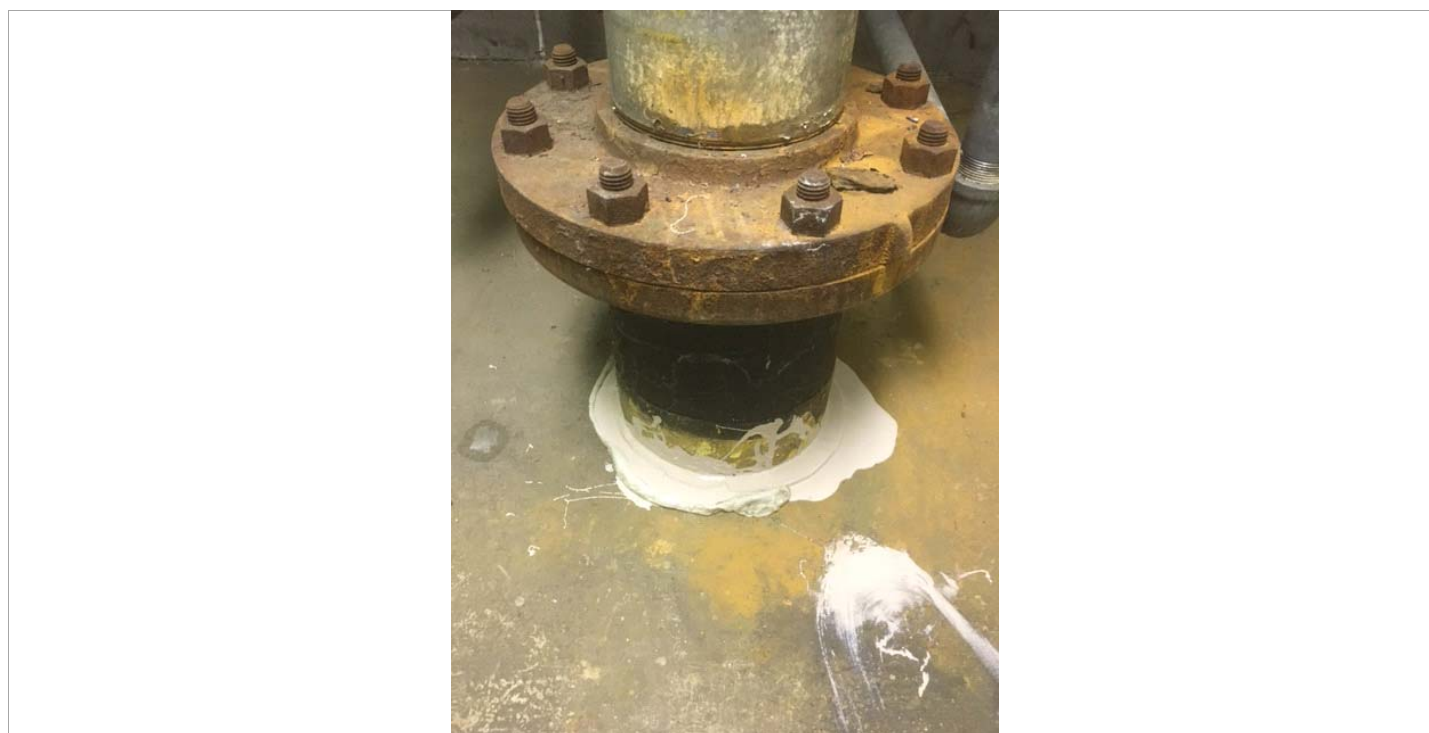
| <b>Description:</b> | Fire water riser pipe - after | | | | |

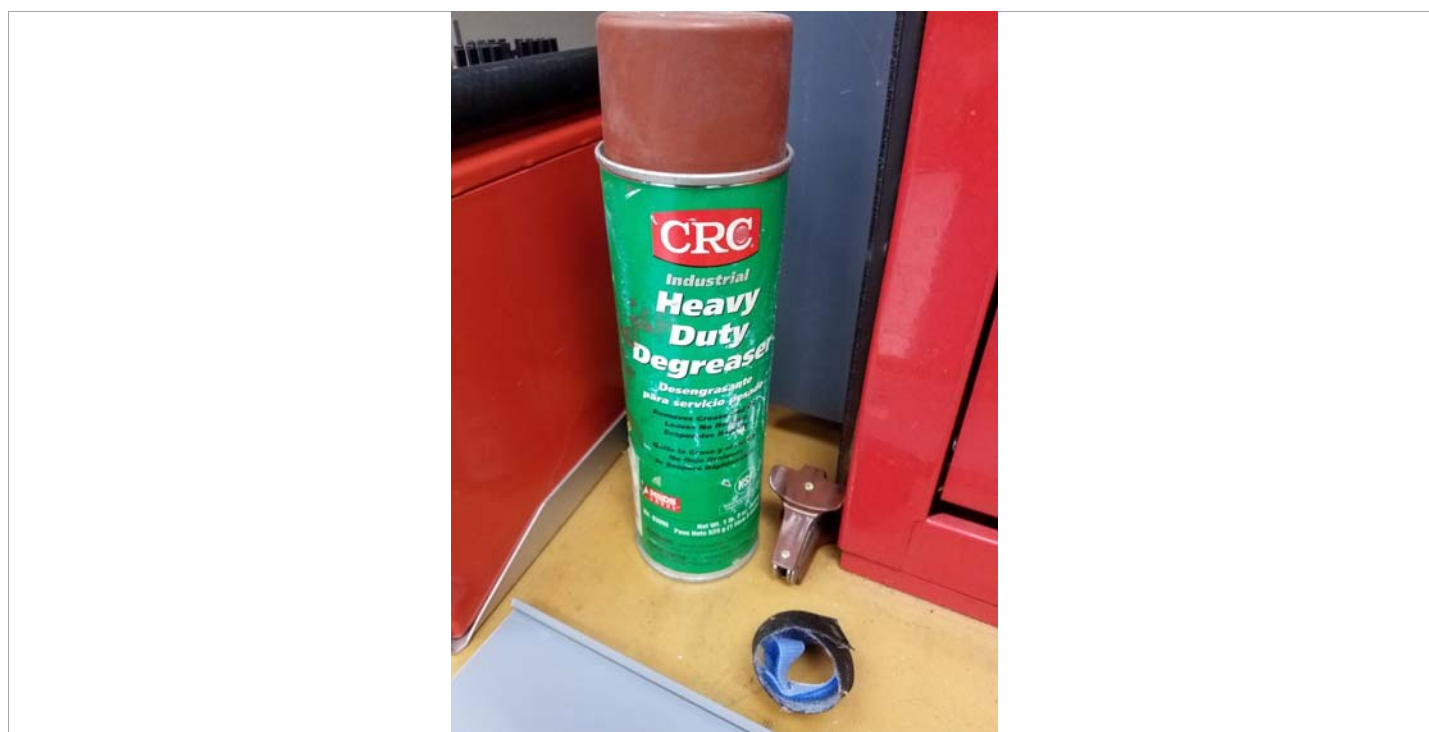
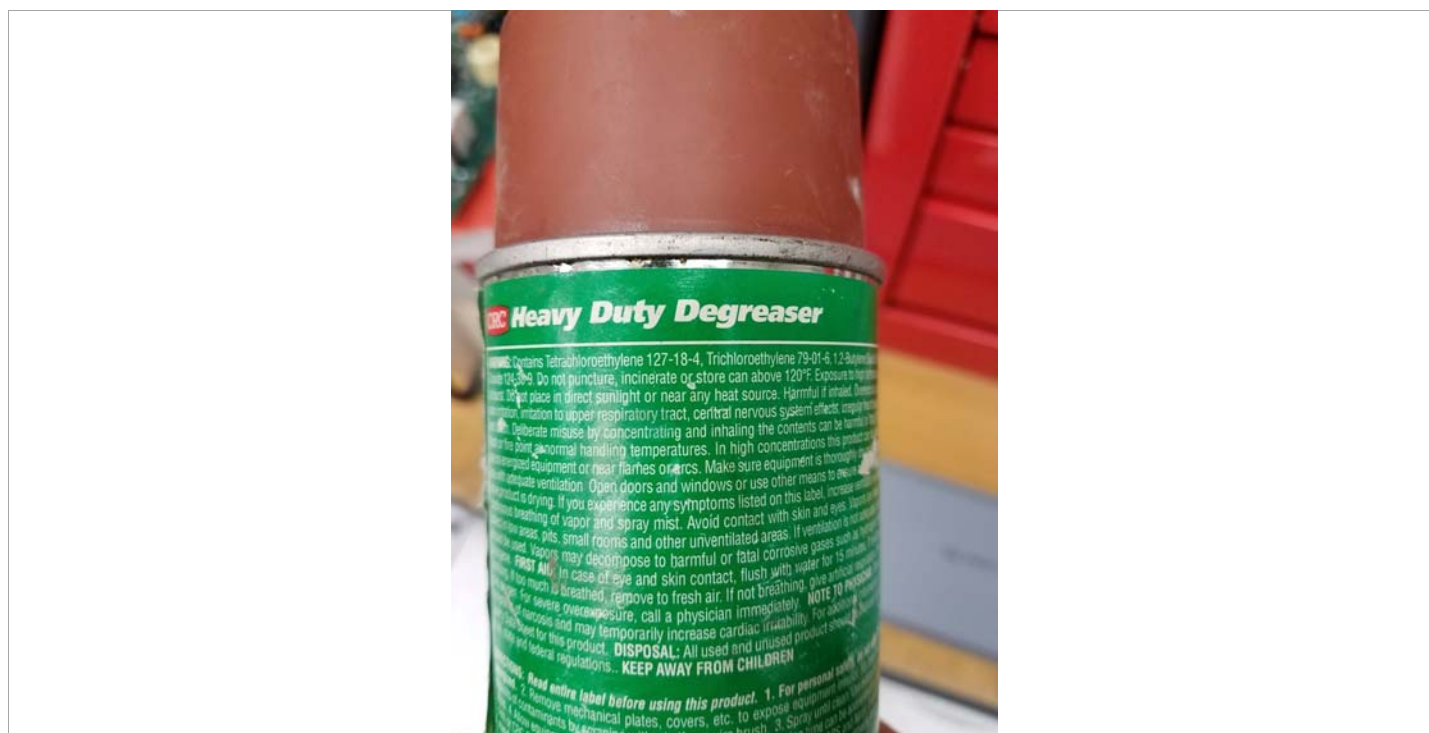
Two of these products, CRC Heavy Duty Degreaser (contains PCE and TCE) and Share Corporation Non-Flammable Safety Solvent (contains TCE) are stored and used in the interior electronic parts storage room to clean equipment. A partially used Share Corporation Non-Flammable Safety Solvent aerosol can was found with the extension spray-tube attached. A ppbRAE 3000 photoionization detector (PID) placed near the end of the extension tube measured elevated VOC levels at around 300 parts per billion (ppb). Dow requested that these products be removed from this interior room and not be used inside the building.

| <b>Description:</b> | Interior computer prats room aerosol can, CRC Heavy Duty Degreaser | | | | |

| <b>Description:</b> | CRC Heavy Duty Degreaser = PCE and TCE | | | | |

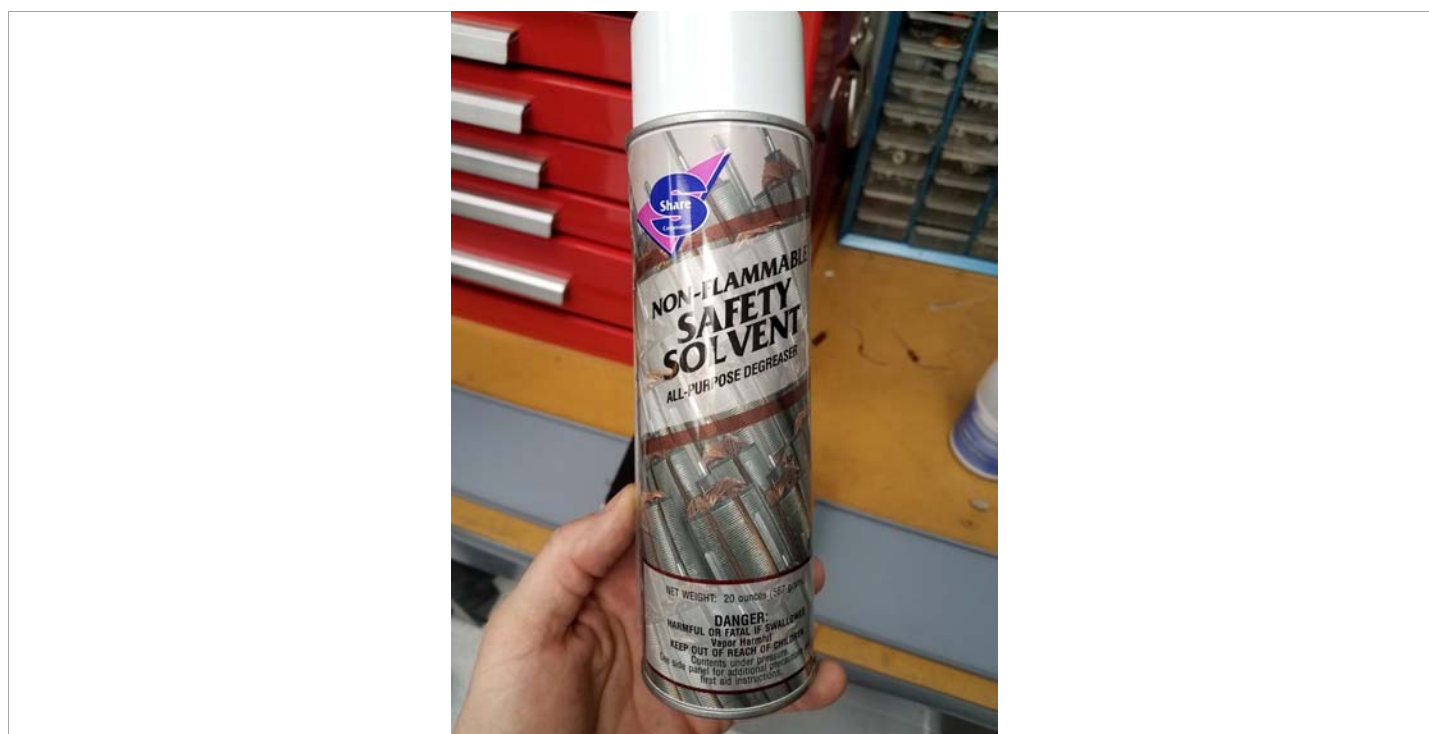
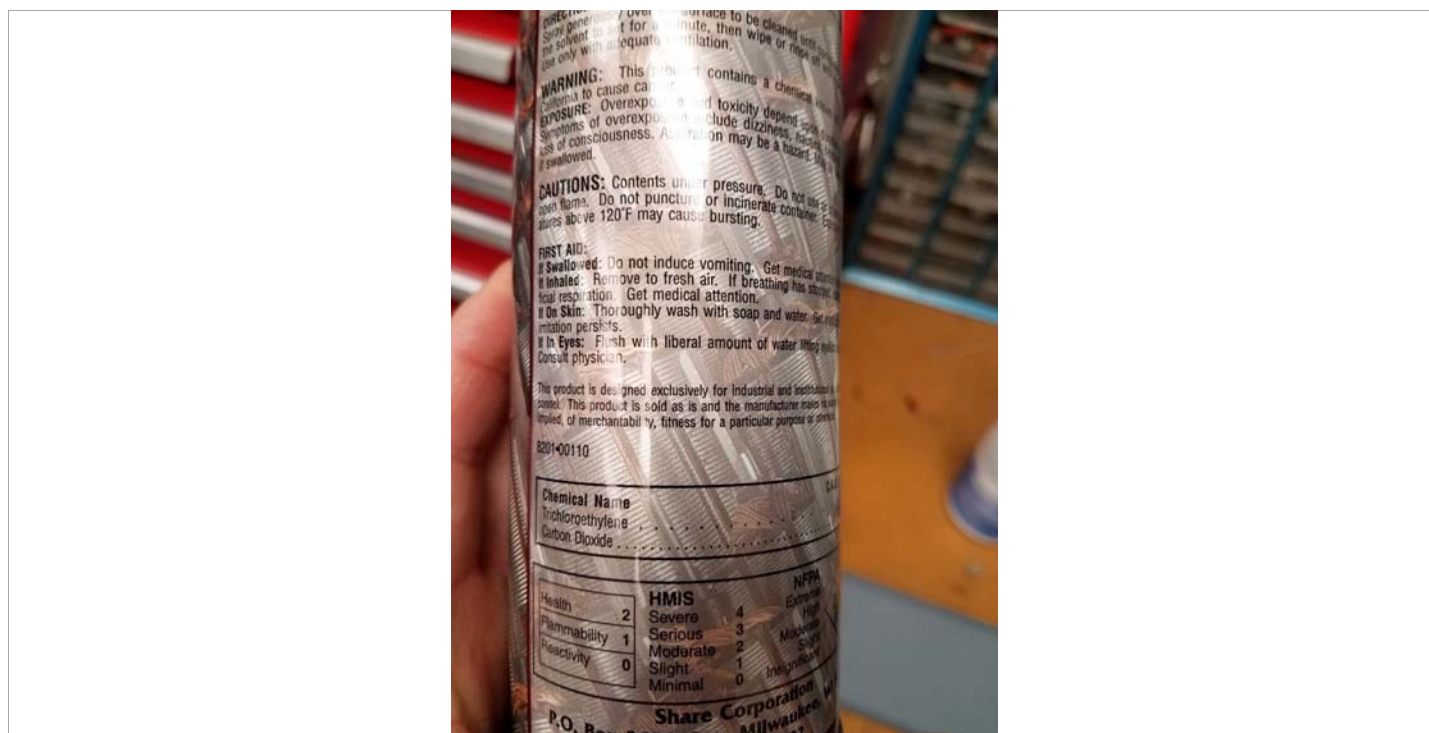
| <b>Description:</b> | Interior computer parts room aerosol can, Share Corporation Non-Flammable Safety Solvent | | | | |

| <b>Description:</b> | Share Corporation Non-Flammable Safety Solvent = TCE | | | | |

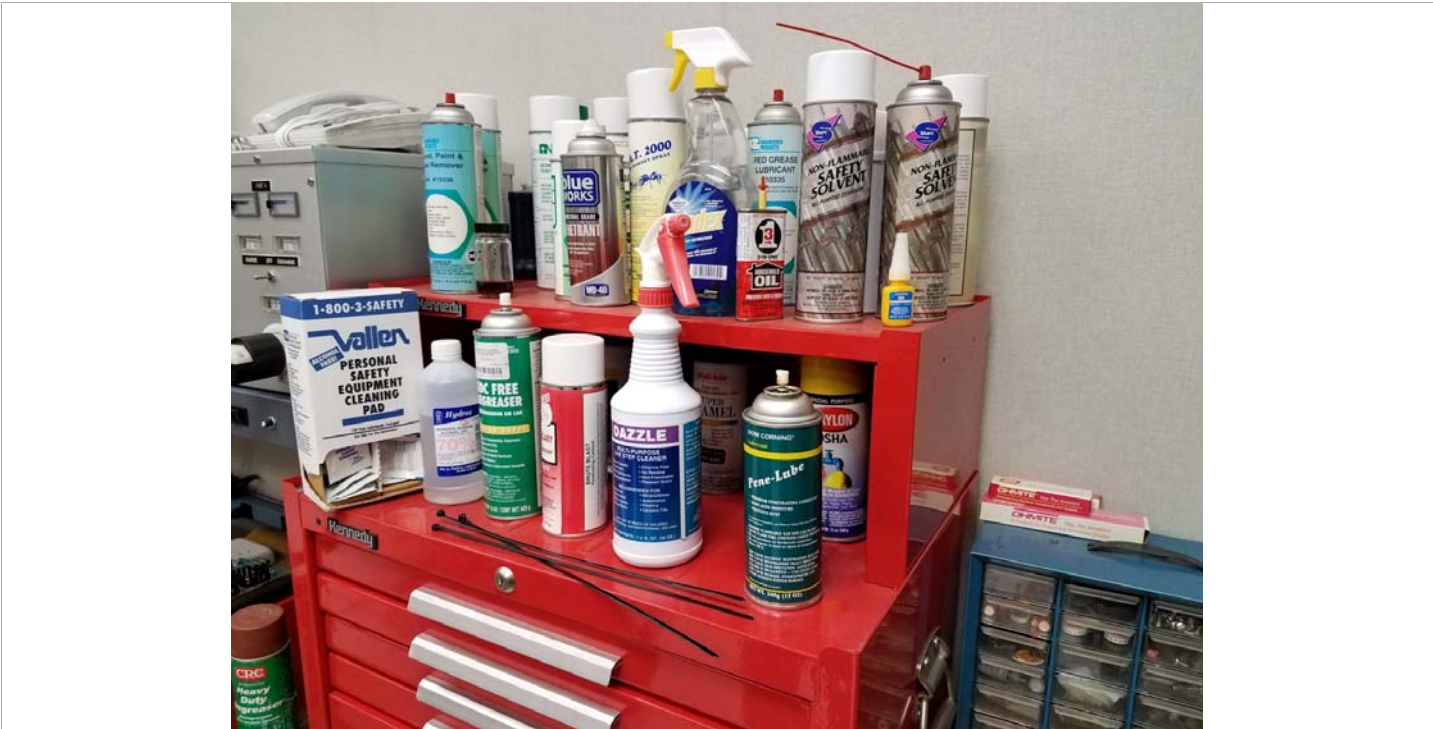
| Description: | Interior Computer Parts Room, spray can storage and use area - Before | | | | |

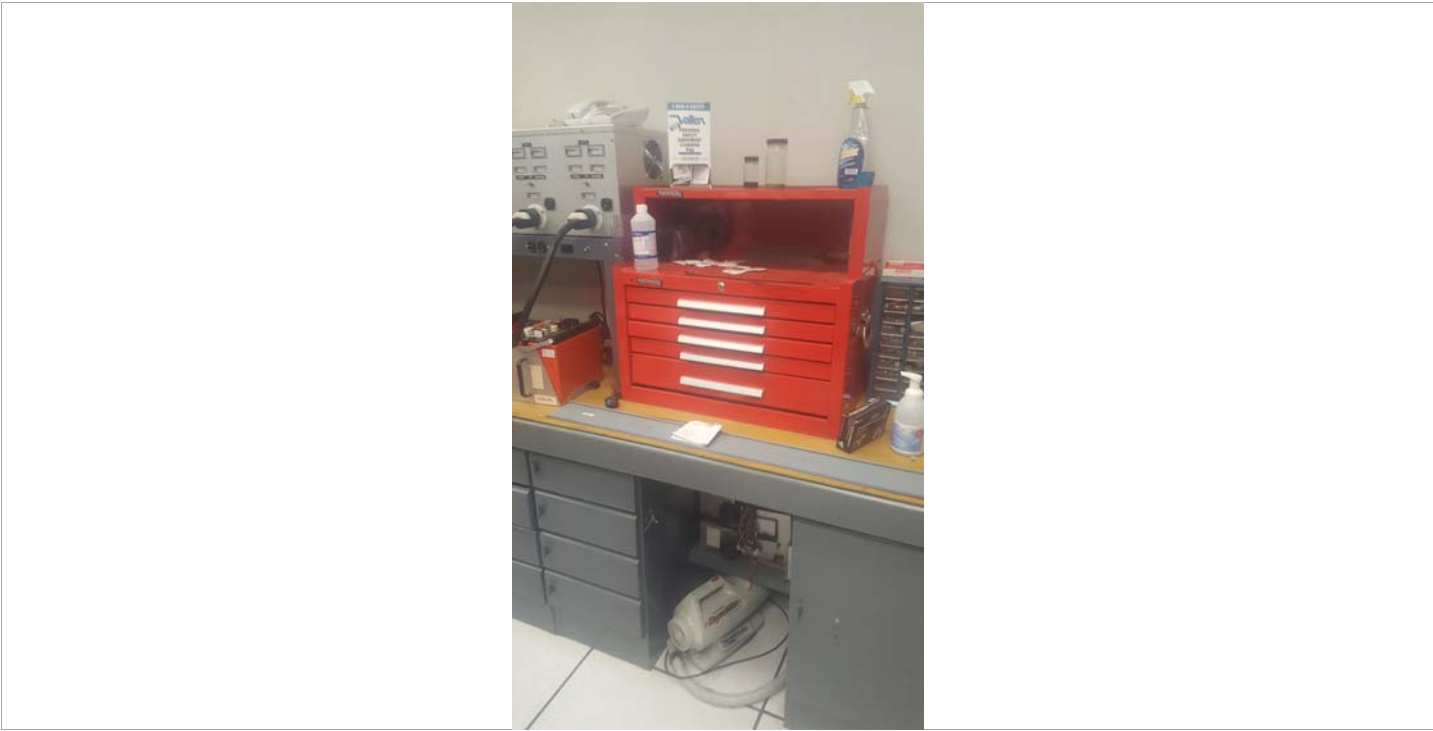
| Description: | Interior Computer Parts Room, spray can storage and use area - After | | | | |

As discussed previously, actions have been taken to mitigate these sources. The cracks/gap have been sealed, the aerosol spray cans have been removed from the central interior electronic parts storage room, and APUs have been placed. The aerosol cans containing PCE and TCE remained in the eastern storage area; however, these products have likely not been used, which would minimize the amount of PCE and TCE off-gassing.

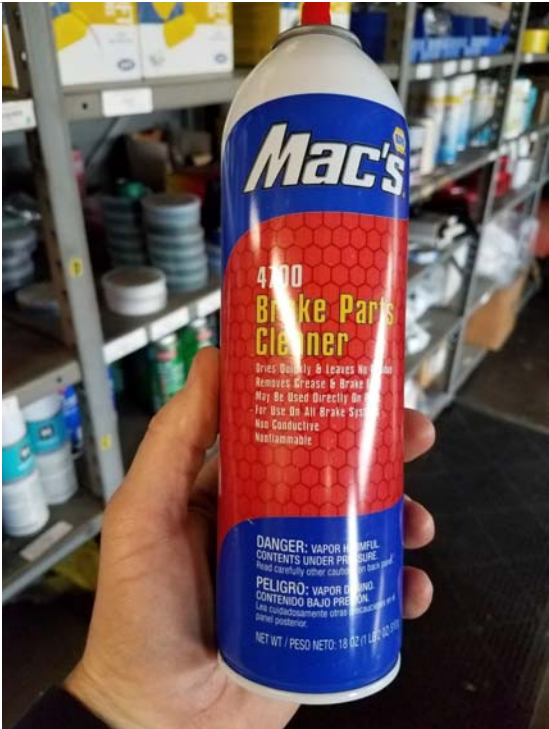
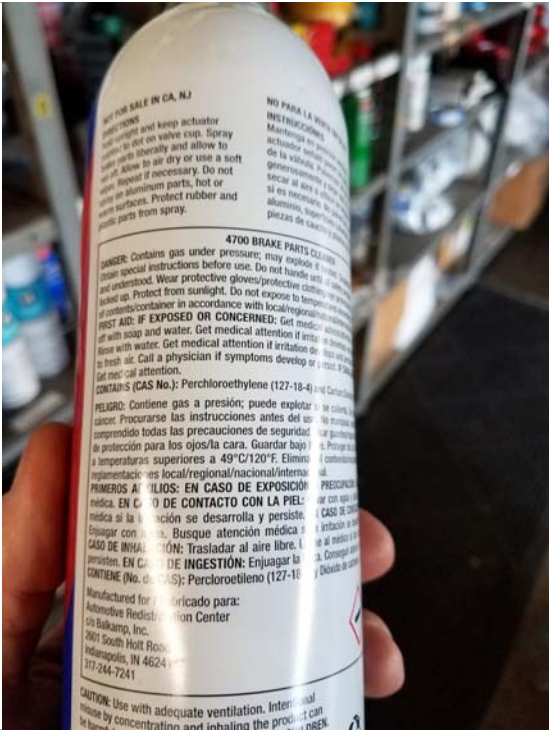
| Description: | Warehouse (SW), Mac's Brake Parts Cleaner | | | | |

| Description: | Mac's Brake Parts Cleaner = PCE | | | | |

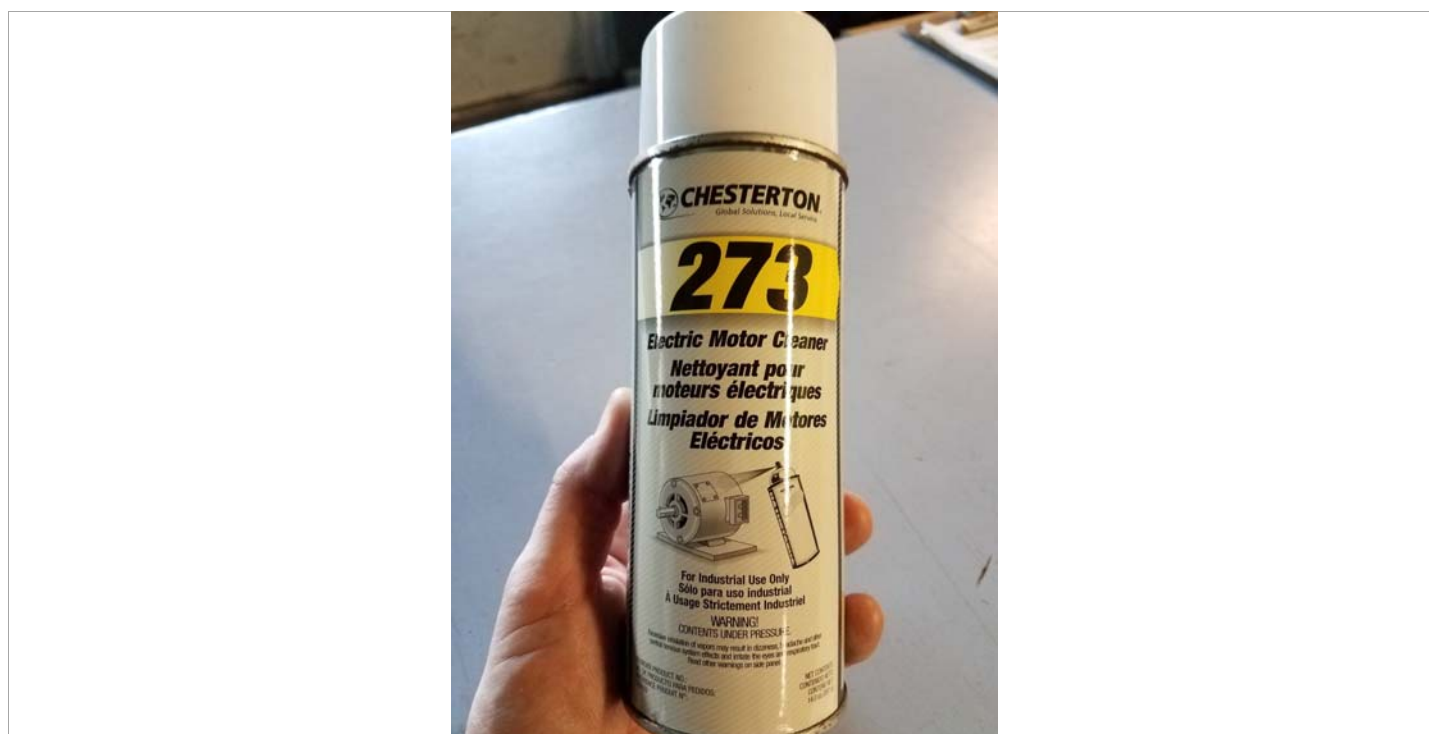
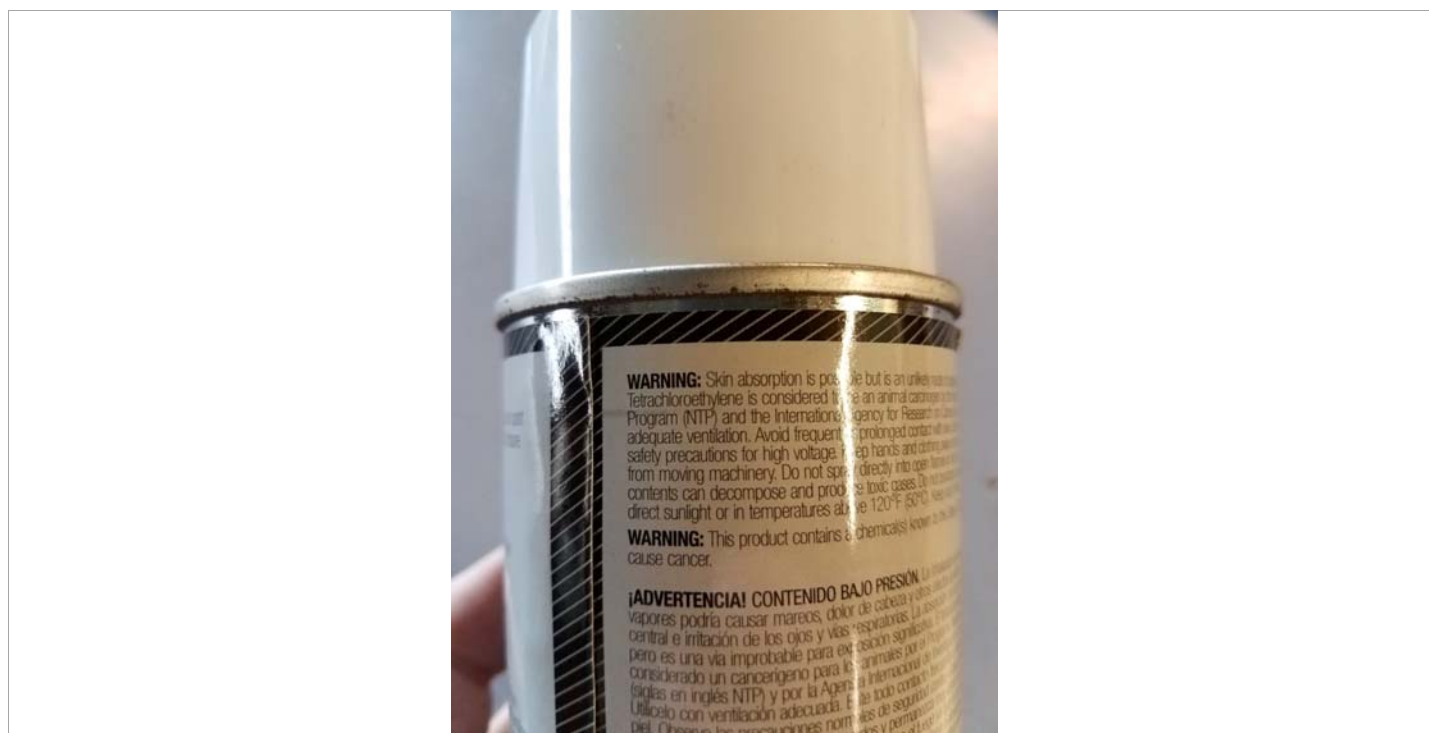
| <b>Description:</b> | Warehouse (SW), Chesterton 273 Cleaner | | | | |

| <b>Description:</b> | Chesterton 273 Cleaner = PCE | | | | |

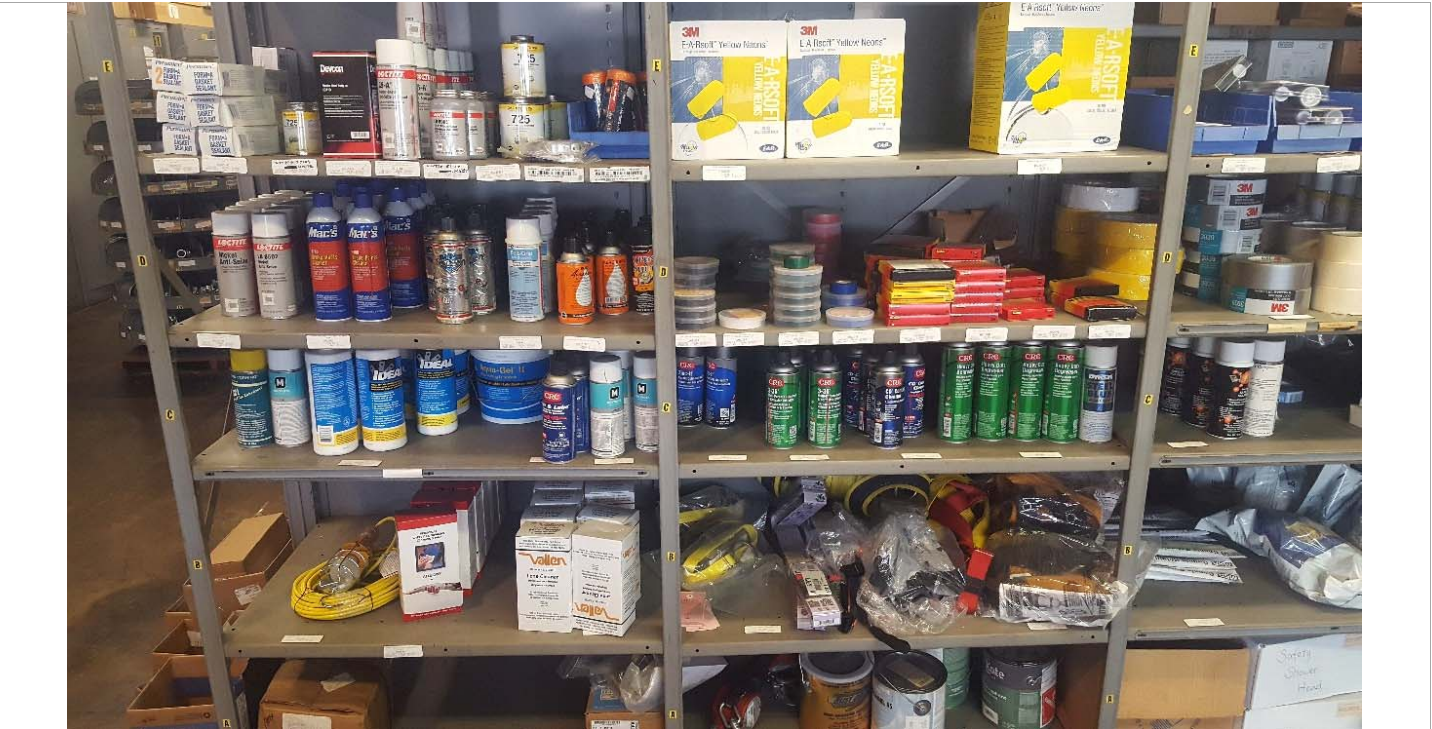
More products were found in the large storage area on the east side of the building. This area included various equipment, parts, chemicals, etc. Aerosol cans, apparently unused, were stored here without the spray tube attached.

| Description: | Warehouse shelving storage | | | | |

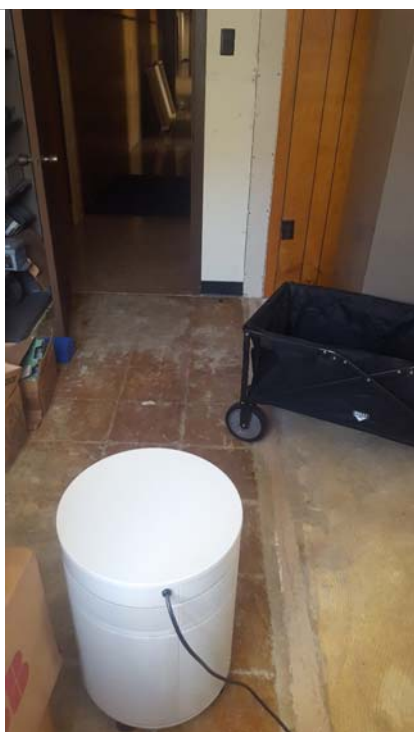
| <b>Description:</b> | APU in southwest corner storage room | | | | |

- Placed two air purifying units (APUs) in rooms with the sealed cracks and where potential indoor sources (open and used aerosol cans) were identified – the southwest corner storage room and the interior electronic parts storage room. The APUs are Airpura C600 Air Purifiers for Chemical Removal that include a 26-pound activated carbon pre-filter. Photographs of the units inside the rooms are included in Attachment 1.

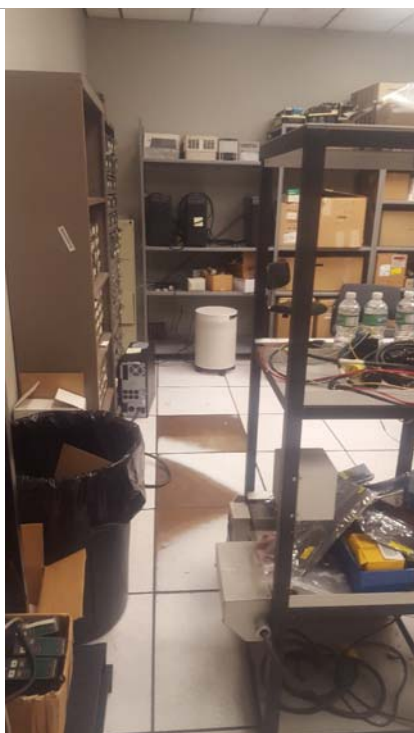
| <b>Description:</b> | APU in interior computer parts storage room with raised floor | | | | |

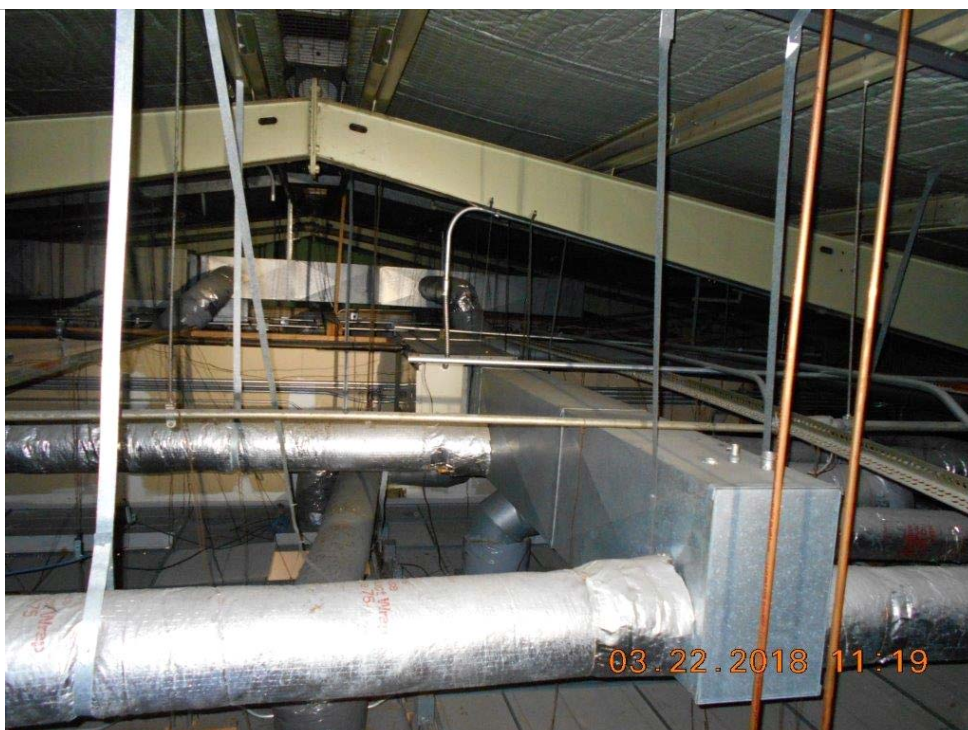
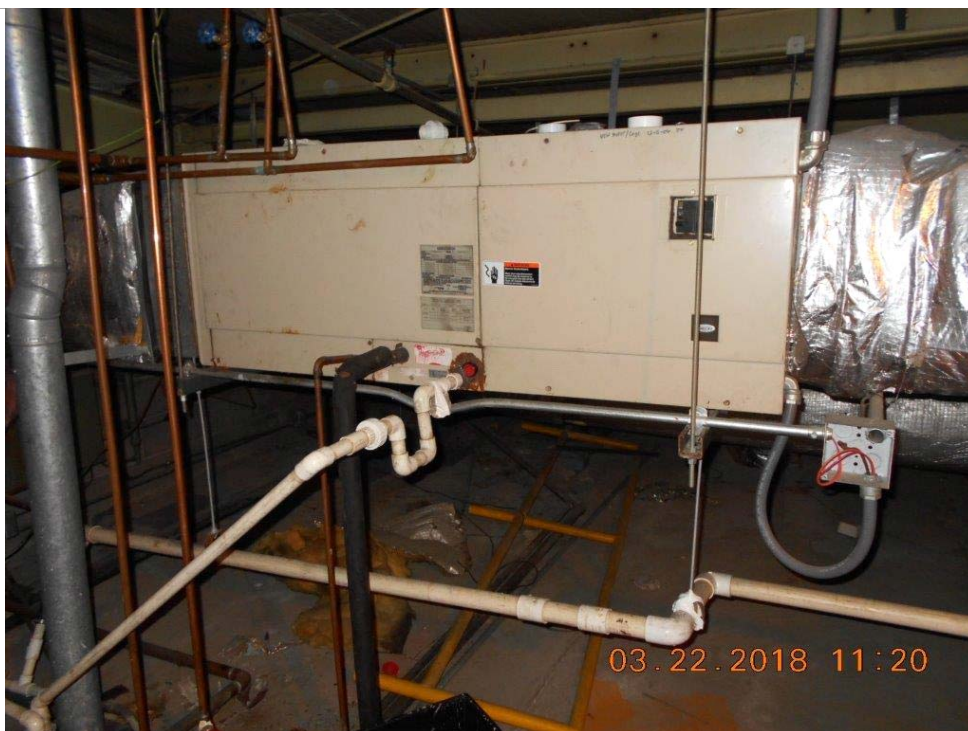
The interior split-system indoor air handling units are suspended from the roof structure and are in an open attic space above the suspended ceilings. Photos in Attachment 1 show how the air handling systems share a common attic space and a continuous ridge vent at the roof center. The ridge vent dampers were usually closed in the above ceiling areas, but normal infiltration and leakage maintain some attic ventilation.

| <b>Description:</b> | Split-system heat pumps in attic serving core areas | | | | |

| <b>Description:</b> | Attic split-system indoor air handling unit, typical unit | | | | |

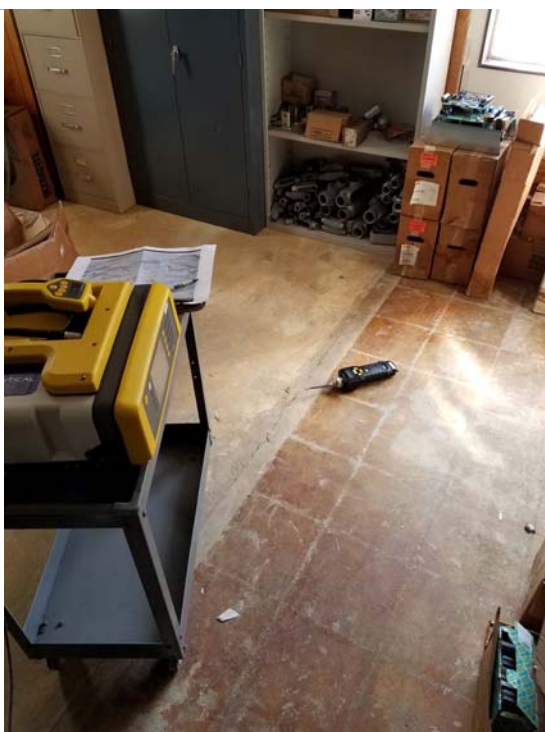
under sinks, near aerosol cans, the breathing zone in offices, conference rooms, storage areas, etc. The following areas had PID readings between 30 and 600 ppb: The crack in the slab in the southwest corner storage room (around 400 ppb), the crack in the interior electronic parts storage room (approximately 30 ppb), the gap around the fire water riser pipe (around 600 ppb), and at the sprayer end of an open aerosol can (approximately 300 ppb).

| Description: | Southwest corner storeroom, HAPSITE breathing zone sample collection and PID screening near the floor crack | | | | HAPSITE ID | PP-1 |

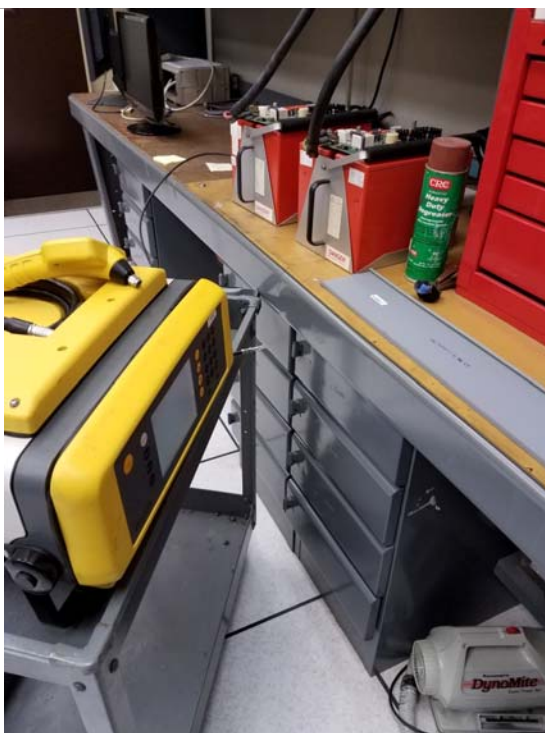
Results for PCE in indoor air were relatively uniform throughout the building and ranged from 1.4 to 10 micrograms per cubic meter ( $\mu\text{g}/\text{m}^3$ ), with the highest concentration detected in the interior computer parts storage room near the open aerosol cans (Attachment 1, Photograph 37). TCE was only detected in the interior electronic parts storage room ( $6.5 \mu\text{g}/\text{m}^3$ ) near the aerosol cans and a small exterior room containing the fire water riser pipe before the gap was sealed ( $1.4 \mu\text{g}/\text{m}^3$ ) (Table 1). As noted above, at least one aerosol can containing TCE appeared to have been used based on the ppbRAE 3000 PID readings of the spray extension tube.

| Description: | Interior computer parts storage room, HAPSITE breathing zone sample collection near the recently used can of CRC Heavy Duty Degreaser | | | | HAPSITE ID | IA-5 |

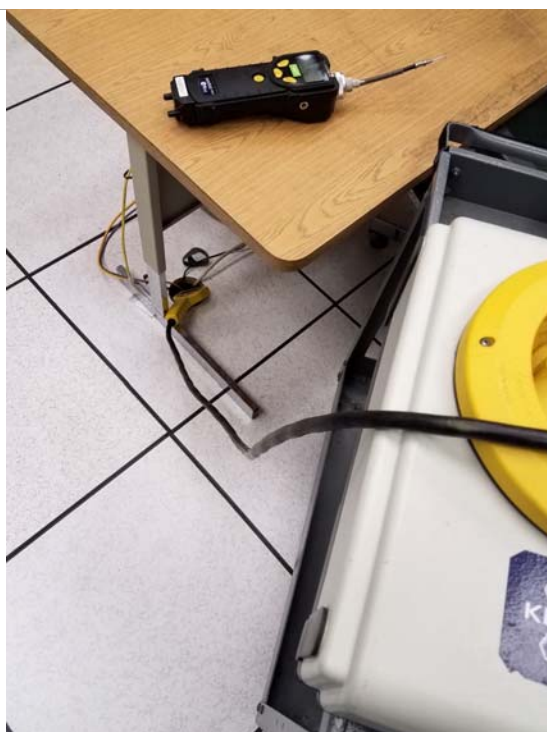
| Description: | Interior computer parts storage room, HAPSITE sample collection of air under the raised floor though a cord opening in the floor raised tile | | | | HAPSITE ID | PP-2 |

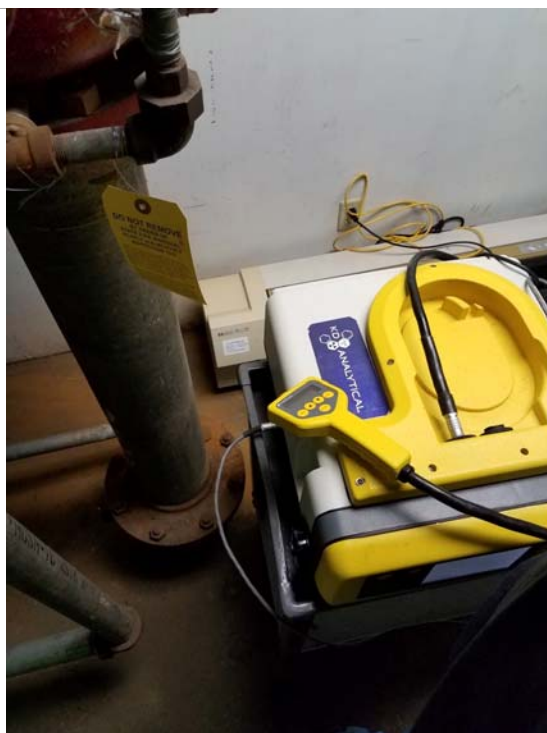
| <b>Description:</b> | HAPSITE sample collection adjacent to the fire water pipe riser in a small exterior room | | | | <b>HAPSITE ID</b> | IA6 |

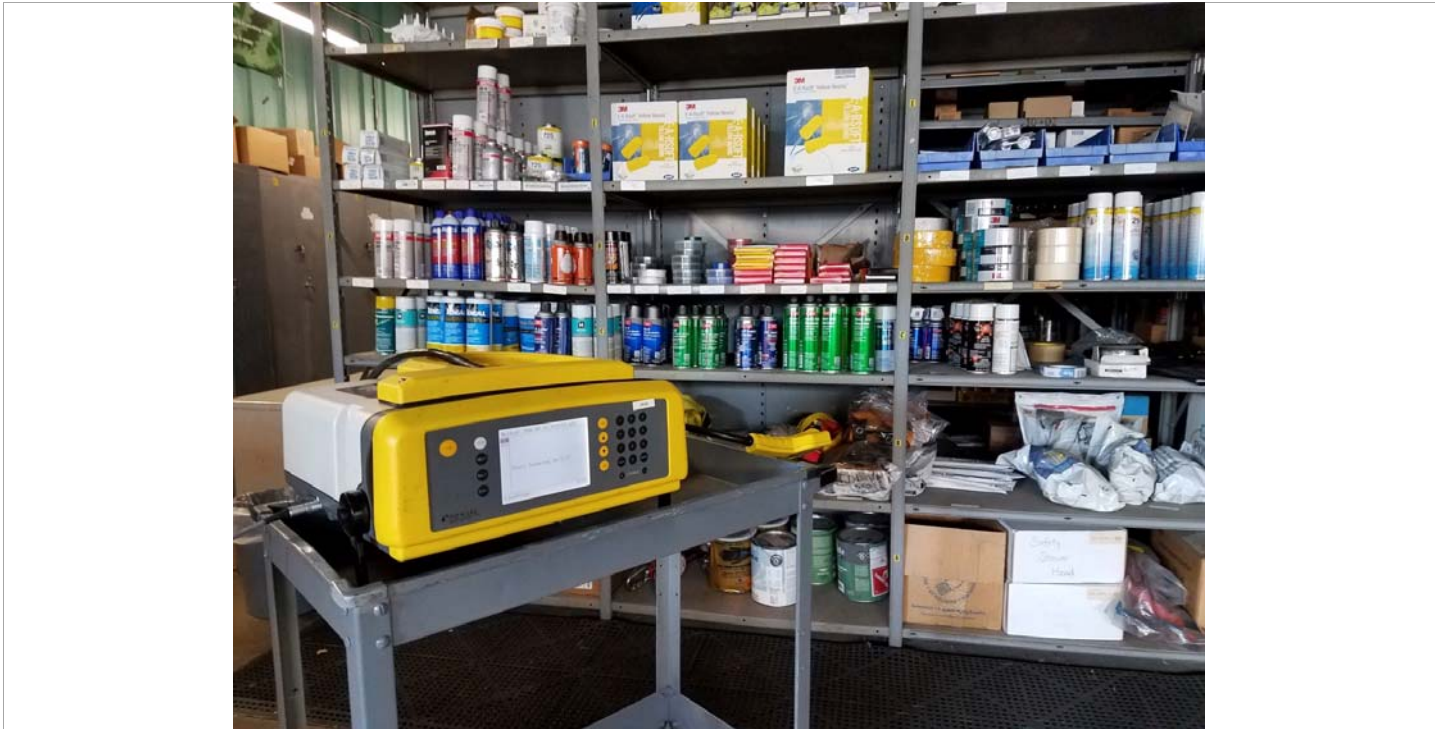
| Description: | Warehouse (SW corner) shelving unit HAPSITE sample collection near spray cans with PCE | | | | HAPSITE ID |
